**EXPERIMENTAL MAINTENANCE PAINTING
OF I-65 IN LOUISVILLE
FEDERAL AID RESEARCH TASK NO. 108**

Research Report
KTC-02-25/FR108-01-1F

October 2002

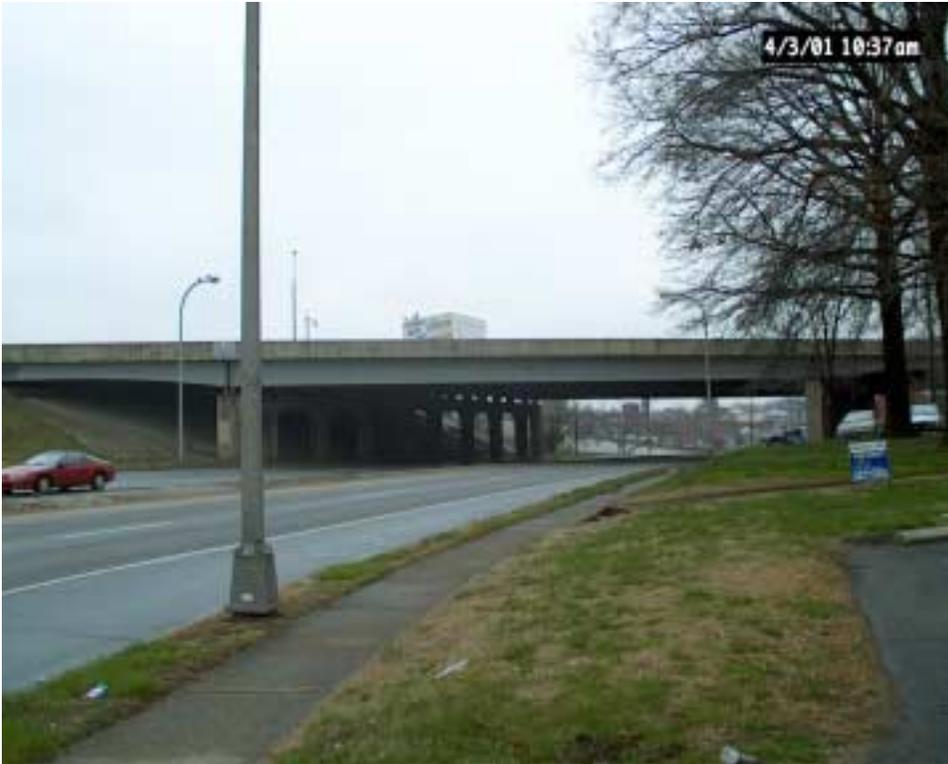
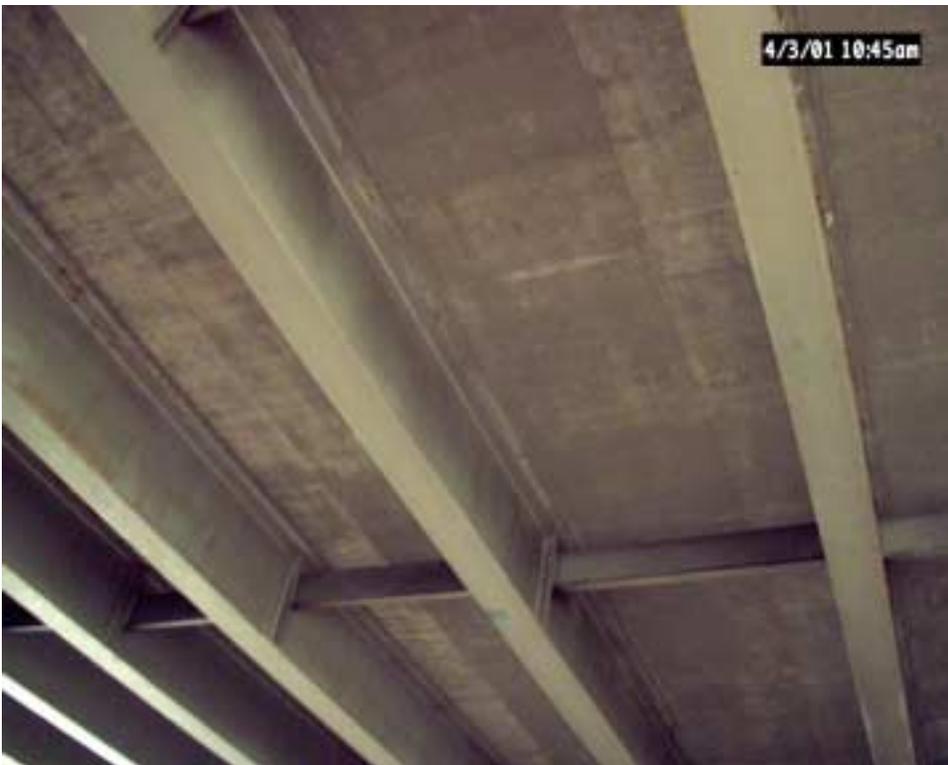
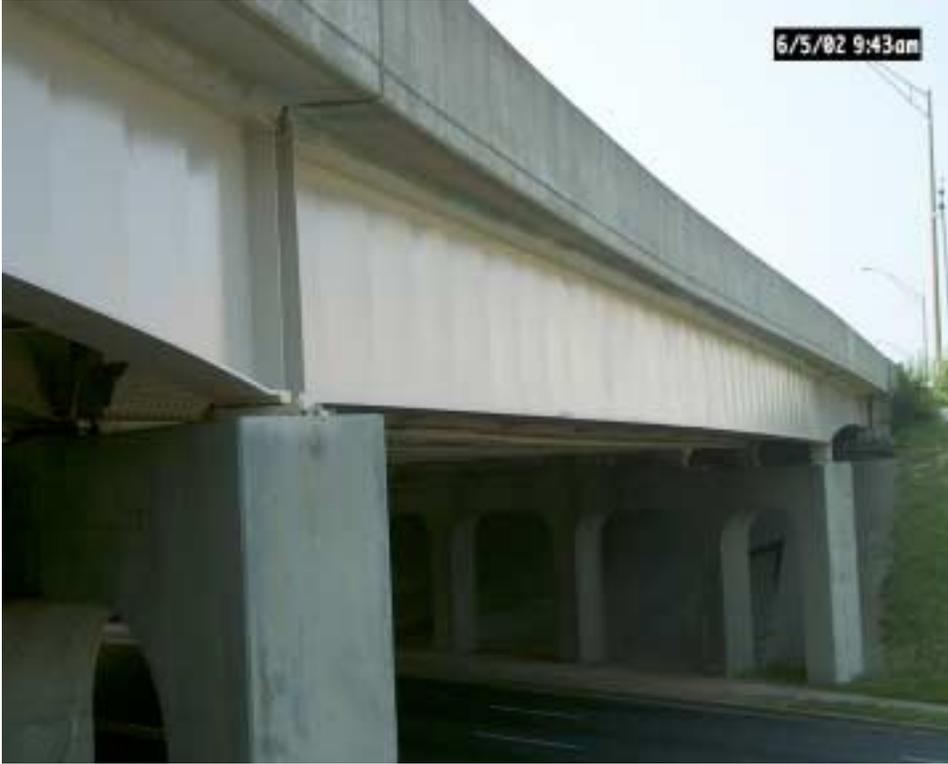
A partial final inspection was completed on November 5, 2001 for some control areas on this bridge. In those areas, holidays and light spots needed to be repaired by applying finish coat. Clean up of the grit and red dust was required. Touch up around rivets and edges, and of holidays and light spots were to be repaired by applying finish coat where needed.

A final inspection was completed on November 16, 2001 for some other control areas. These areas had holidays and light spots which required the application of the finish coat. The bridge was found to be within conformance to the **Standard Specifications and Special Notes** for this project. The work area was to be cleaned and all debris and waste removed from site. Personnel from KYTC Central Office Division of Construction and District 5, the Kentucky Transportation Center, and the contractor were present for that final inspection.

Figure 81. View of bridge at Eastern Parkway before painting.

Figure 82. View of girders on bridge at Eastern Parkway before painting.

Figure 83. View of bridge at Eastern Parkway after painting.

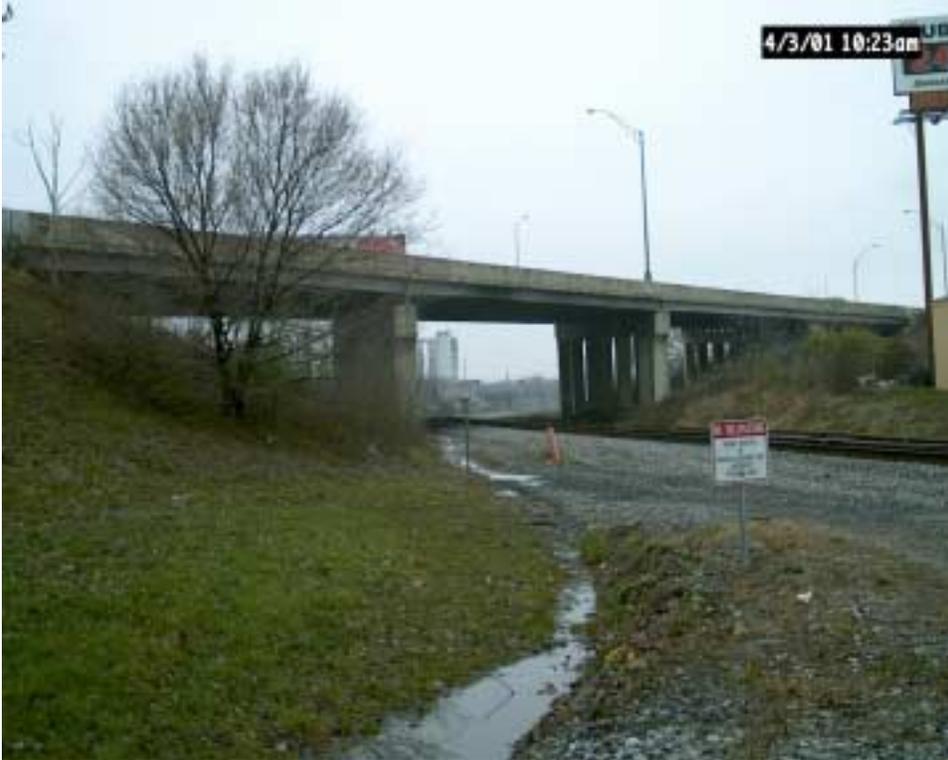
Figure 84. View of the bridge at Southern Railway before painting.

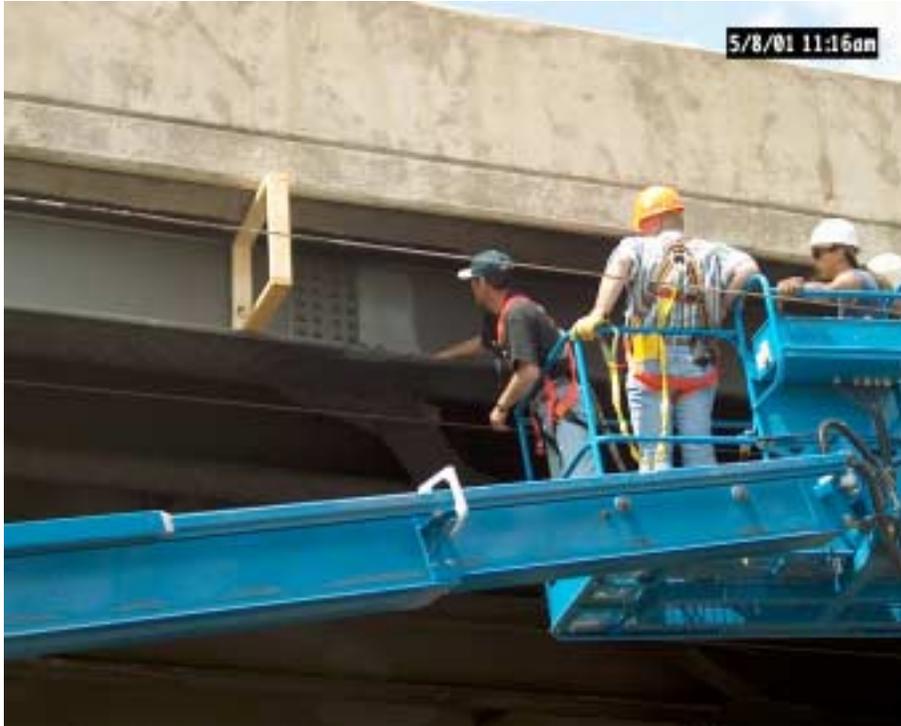
Figure 86. Solvent cleaning test patch being performed by the contractor on the bridge at Southern Railway.

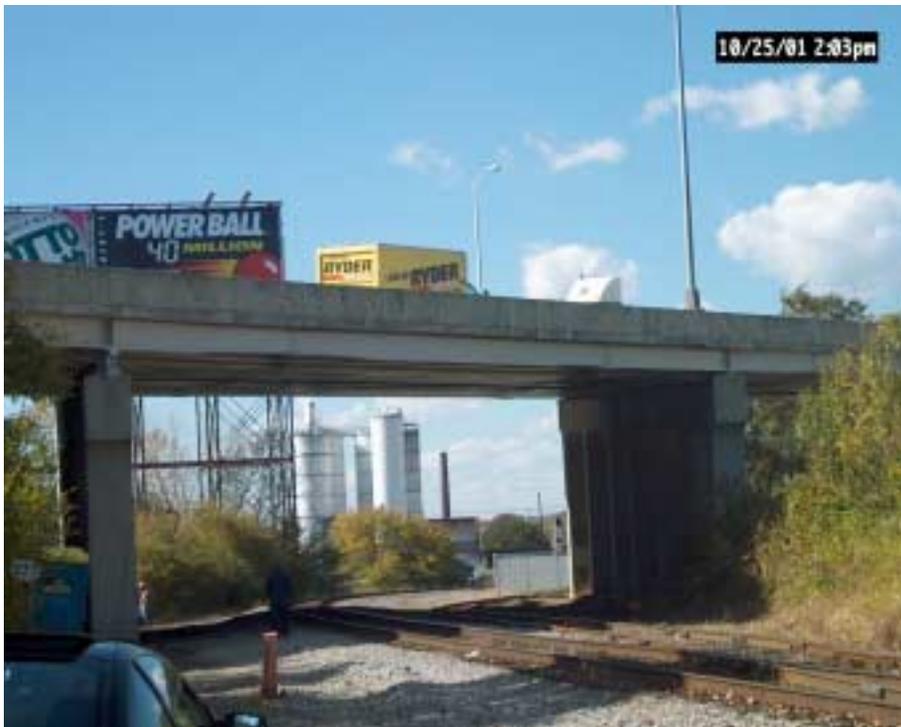
Figure 87. Bridge at Southern Railway after painting.

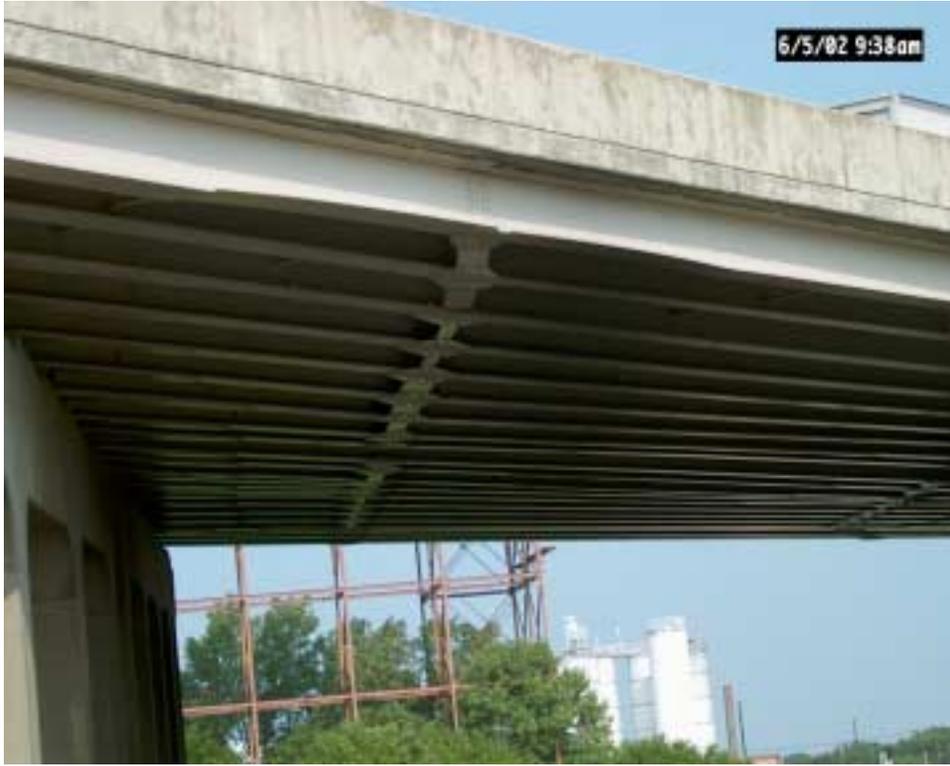
Figure 88. View of girders at the Southern Railway Bridge after painting.

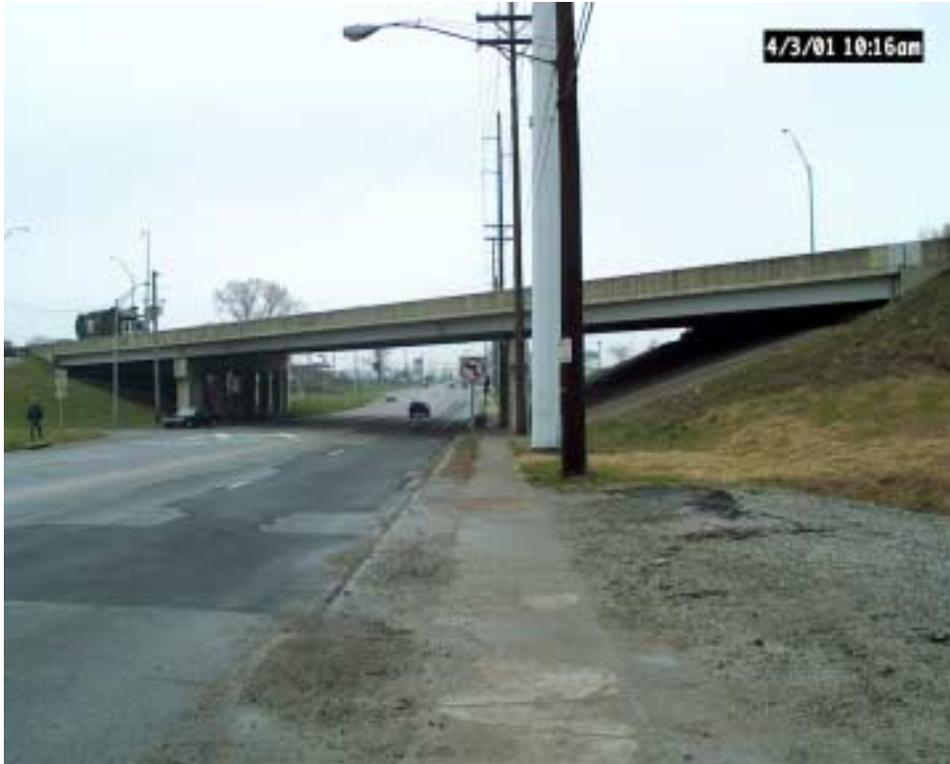
Figure 89. View of bridge at Crittenden Drive before painting.

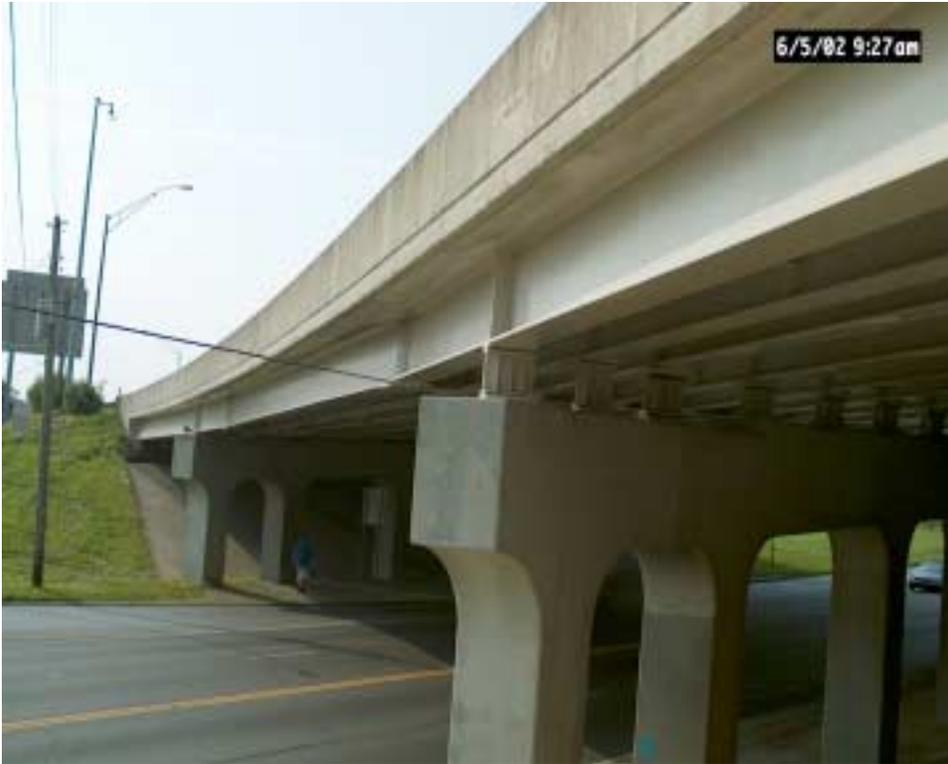
Figure 91. View of bridge at Crittenden Drive after painting.

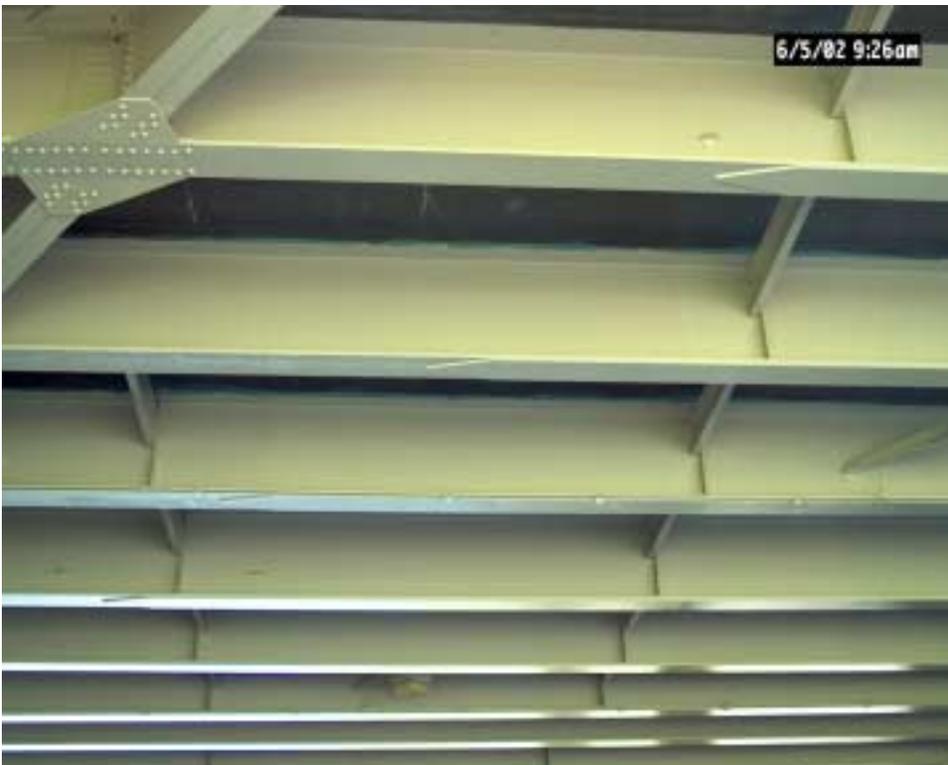
Figure 92. View of girders on the bridge at Crittenden Drive after painting.

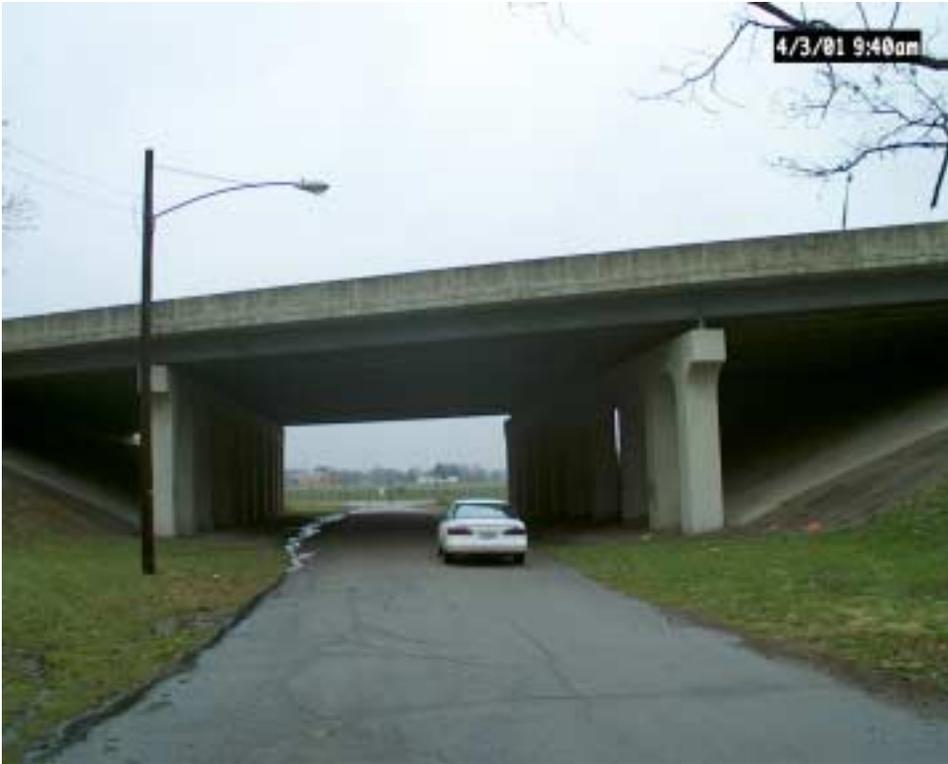
Figure 100. View of bridge at Manning Street before painting.

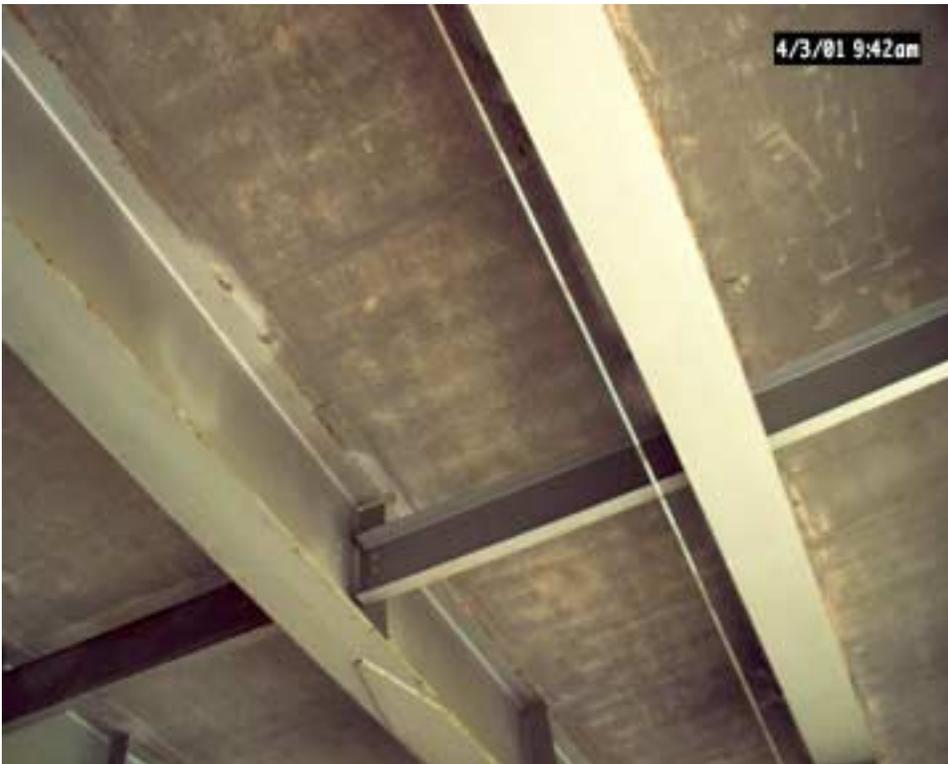
Figure 101. View of girders on the Manning Street Bridge before painting.

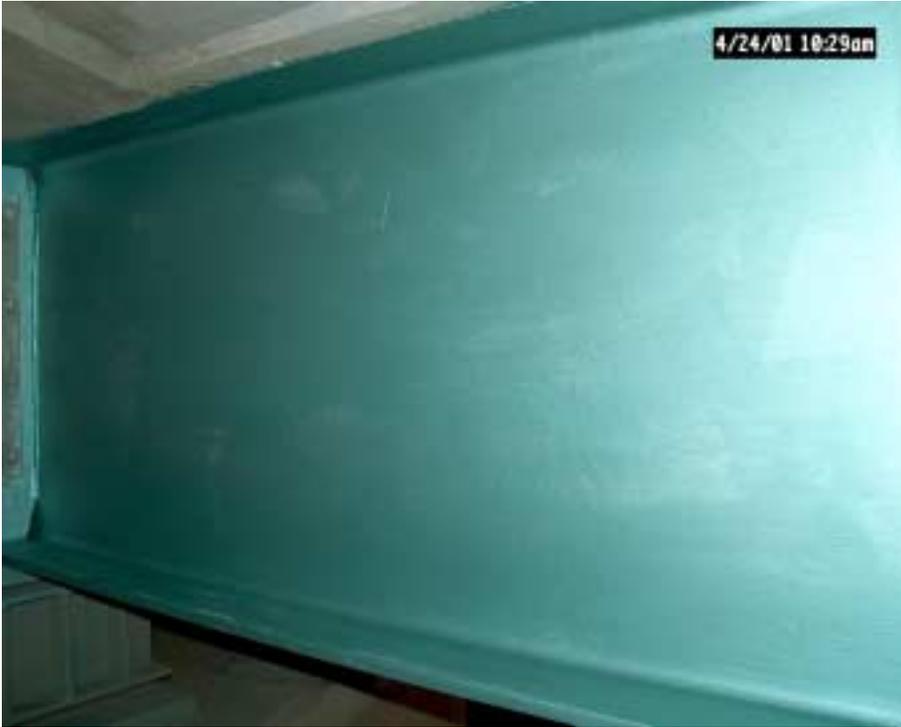
The mandatory test patch for the whole project was done on this bridge, with the contractor beginning the blasting operation on April 6, 2001. On April 9, 2001 the organic zinc rich primer was applied at 5.0 to 6.0 mils wet film thickness (WFT) by spraying. The following day, the intermediate coat of tinted moisture cure aluminum polyurethane was applied by spraying at 4.0 to 6.0 mils WFT. The next morning, the finish coat was applied at 4.0 to 6.0 mils WFT. The finish coat was to be acrylic polyurethane. Later that afternoon, the test patch was approved. The contractor continued painting rest of that structure.

Figure 104. Portion of the Manning Street Bridge where the intermediate coat of the test patch was applied.

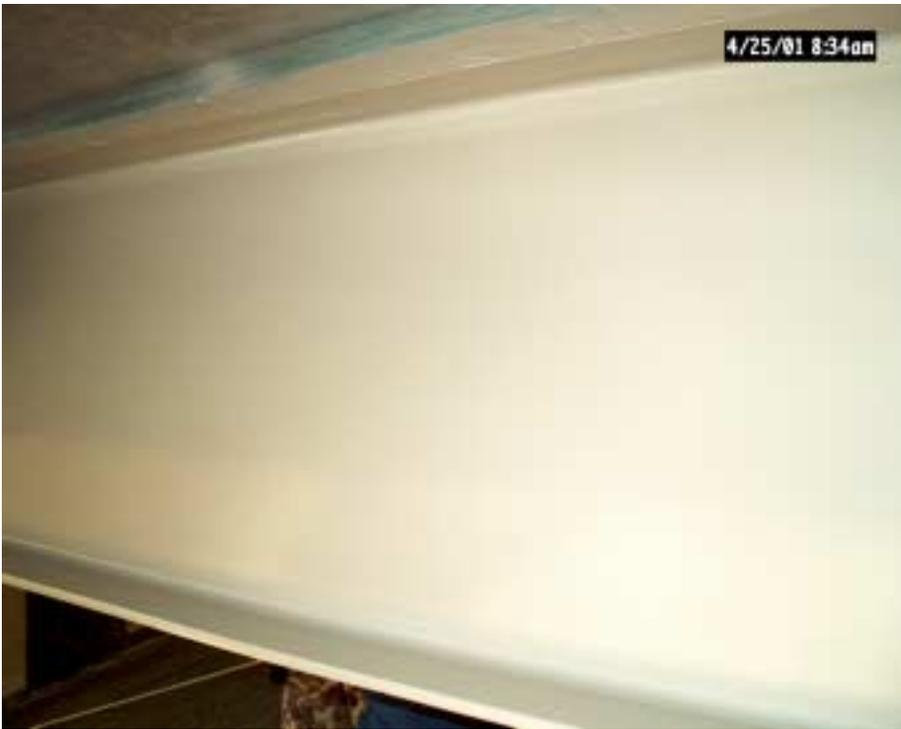
Figure 105. Area of the Manning Street Bridge where the finish coat of the test patch was applied.

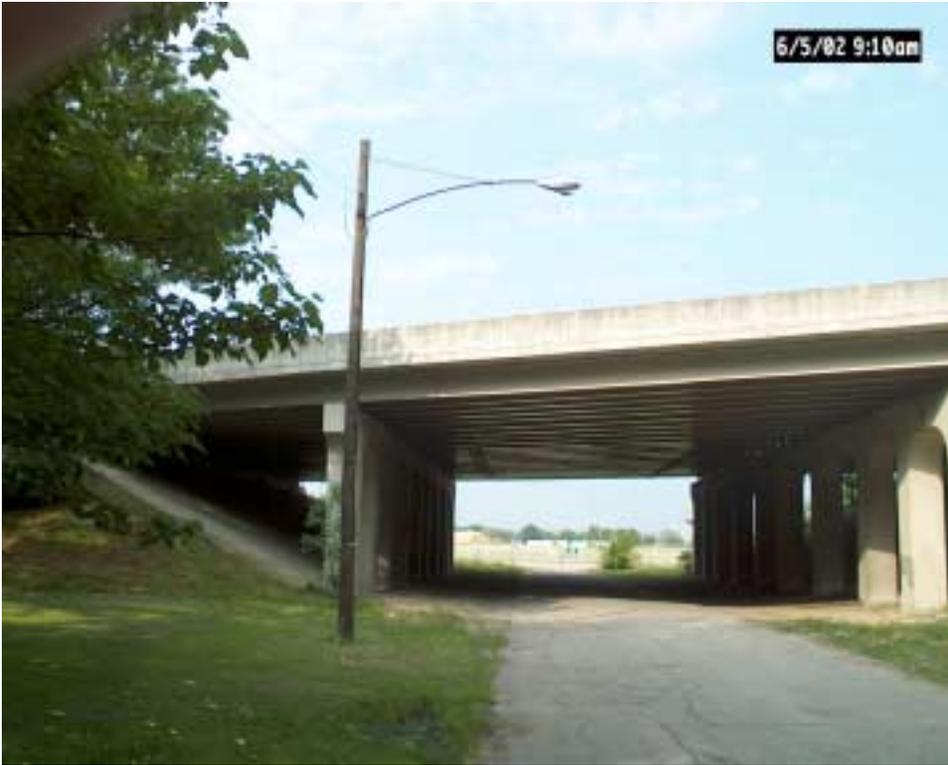
Figure 106. View of the Manning Street Bridge after painting.

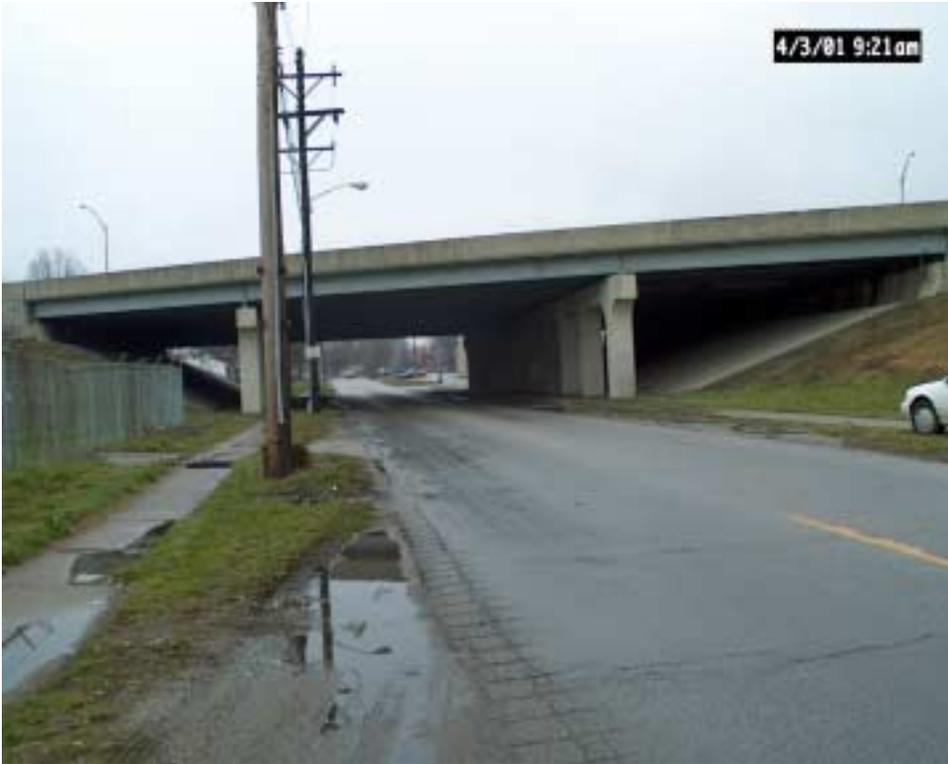
Figure 1089. View of the Phillips Lane Bridge before painting.

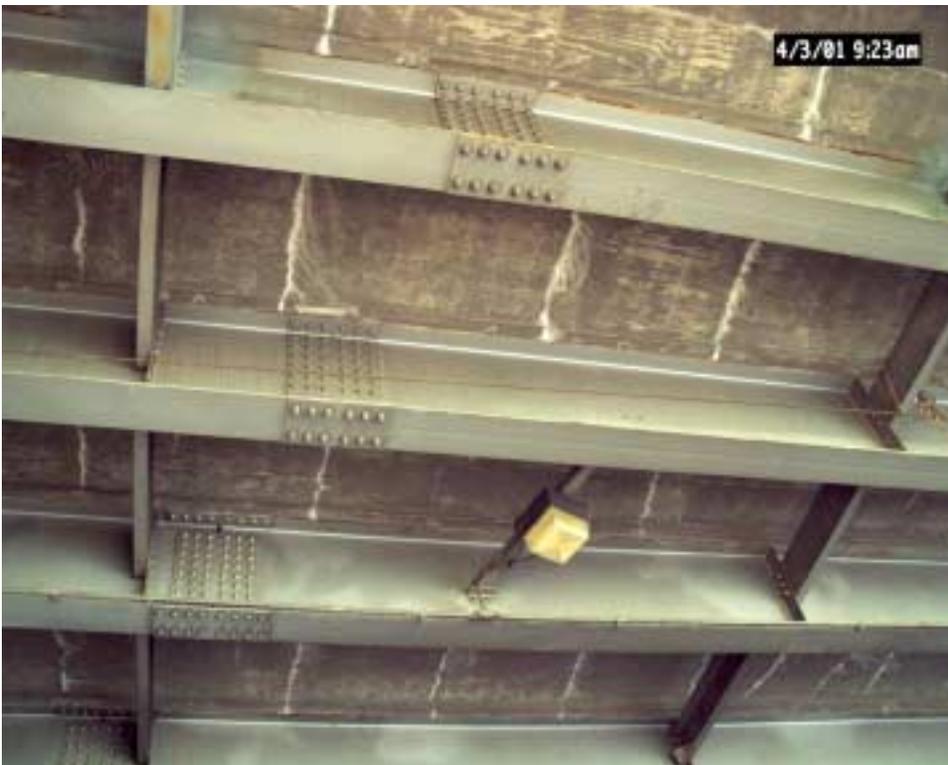
Figure 109. View of girders at the Phillips Lane Bridge before painting.

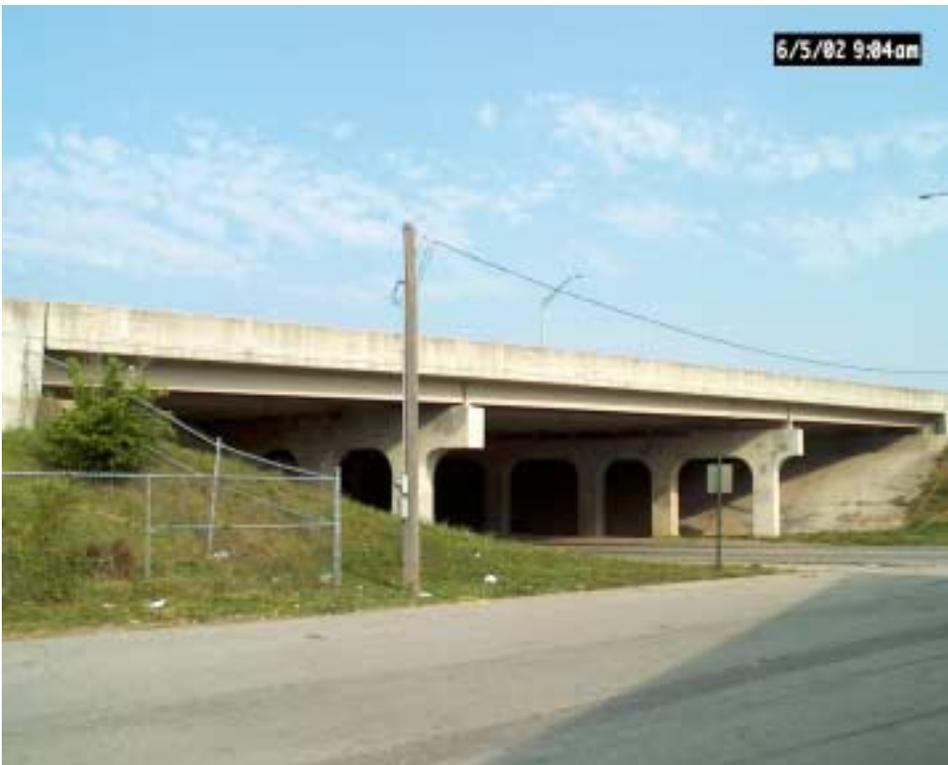
Figure 1102. View of bridge at Phillips Lane after painting.
